# Manhole Inspection Summary

Manhole # S41CC\_020MH

Insp Date: **11/25/08 9:45 AM**

**Location** Address: **910 n caroline st**

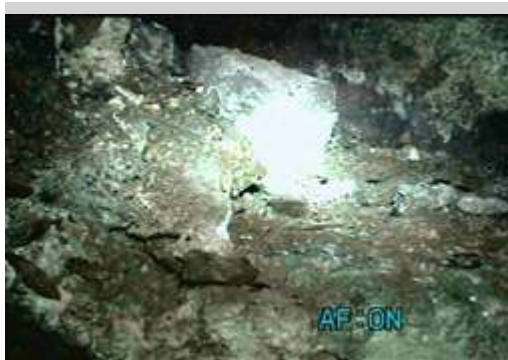
Defect 5

Condition: ☐ Sound ☐ Cracked ☐ Root Intrusion ☐ Deteriorated ☐ Leaks ☒ **Debris**

bench debris

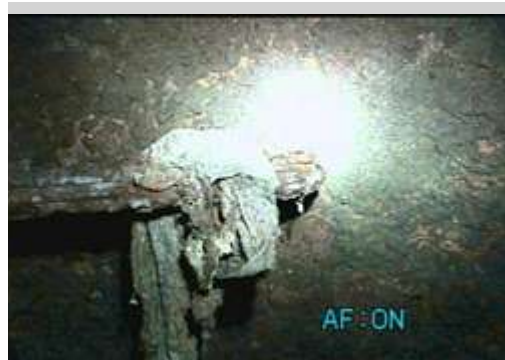
Defect 4

☒ **Evidence Of Surcharge** Depth: **6.** (ft.) ☐ Active Surcharge Present

surcharge evidence 6.16 feet

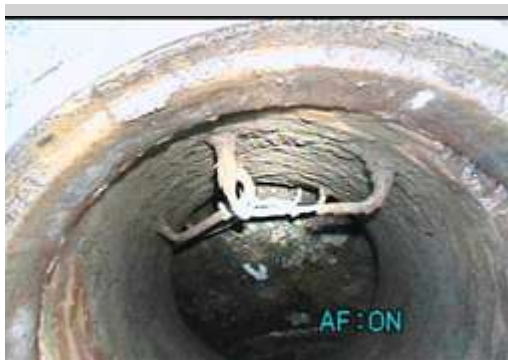
Defect 3

Count: **5** Missing: **1** ☒ **Corroded**

steps corroded

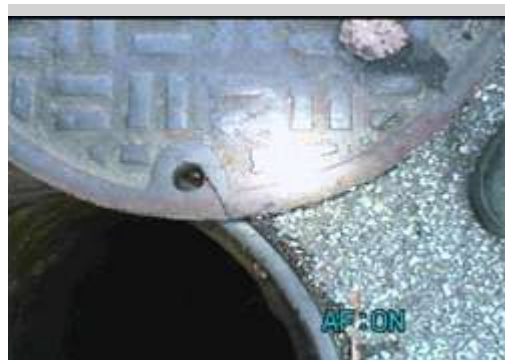
Defect 2

Condition: **Cracked**

cracked cover

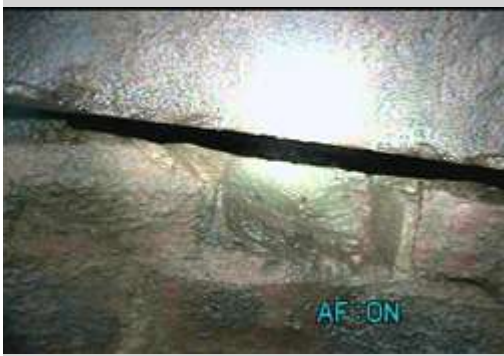
### Defect 1

Condition: ☐ Sound ☐ Cracked ☐ Root Intrusion ☒ **Loose Brick** ☒ **Deteriorated**

chimney gap at frame joint
